## Restoration of Cuernavaca Stucco

(From a helpful homeowner)

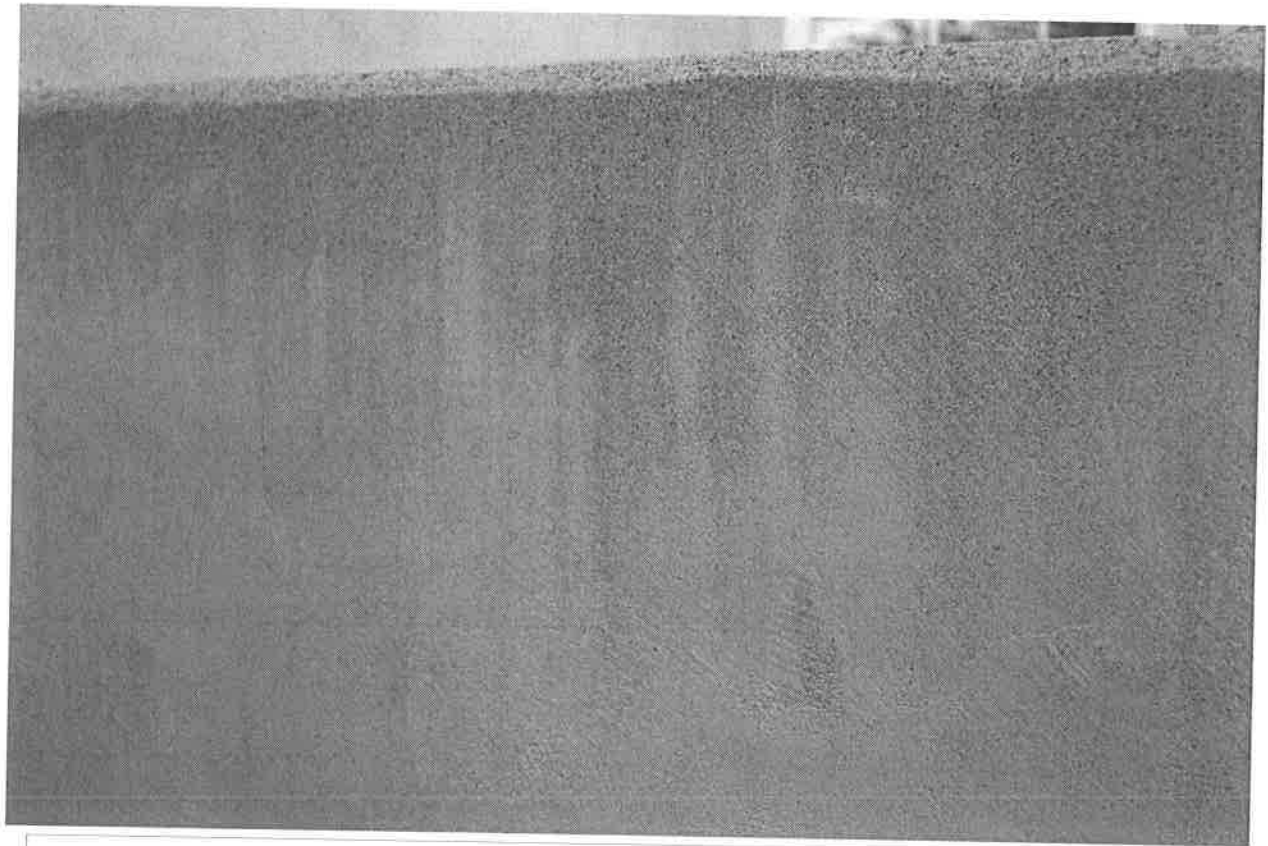
At Cuernavaca "discoloration" of stucco has appeared on all units along the roof

lines where rain water runs down from horizontal surfaces. It does not appear on the roof lines where a tile roof protects the stucco and prevents direct exposure to rainwater running off the roof. The "discoloration" may be reduced somewhat by power washing to remove the black material but it cannot be removed with any amount of power washing. A close examination of the "discoloration" reveals that the surface layer of the stucco has been etched away. All horizontal surfaces collect a black layer with time. It is organic as indicated by its removal by snails in a few places. My guess is that the origin of the black layer is in road or freeway debris, including tire particles. Tire treads contain 2.5% sulfur, which when oxidized will produce sulfuric acid. In any case, an acid is produced. The acid dissolves the surface of the horizontal stucco surface, and washes down the vertical surface where it etches away the fine surface of the stucco exposing the sandier undercoat. Where the horizontal surface is not stucco, the acid still washes down vertical stucco surfaces and dissolves the stucco.

**Wall illustrating etching of surface layer of stucco at top of wall**

This etched surface can be restored very easily with a “fog coat”. Although customarily applied commercially by spraying, I have found that it is easily applied with a paint brush. La Habra Fog Coat No. 71 Miami Peach is an excellent match for our stucco. This is a cement product shipped in a bag like any other cement. It is mixed with water before applying and sets up in a few hours and continues to cure for days. The finished surface is indistinguishable from the original surface and wets with water as expected for any stucco surface. The material is very inexpensive. The major cost is in application. Spraying generally requires scaffolding and masking and an experienced applier. Application with a paint brush requires only a ladder but longer application time.

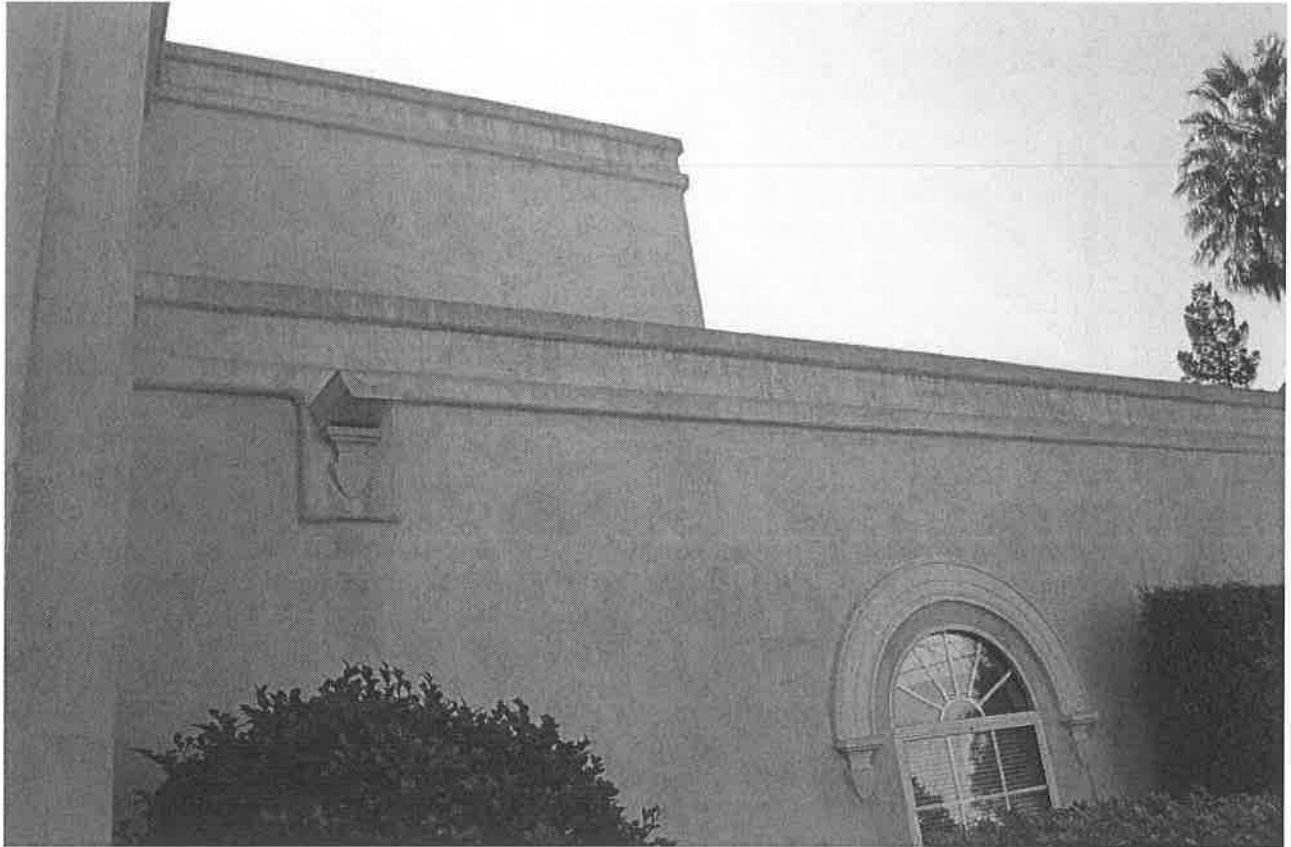
**Example of etching of stucco along roof line below horizontal surfaces**

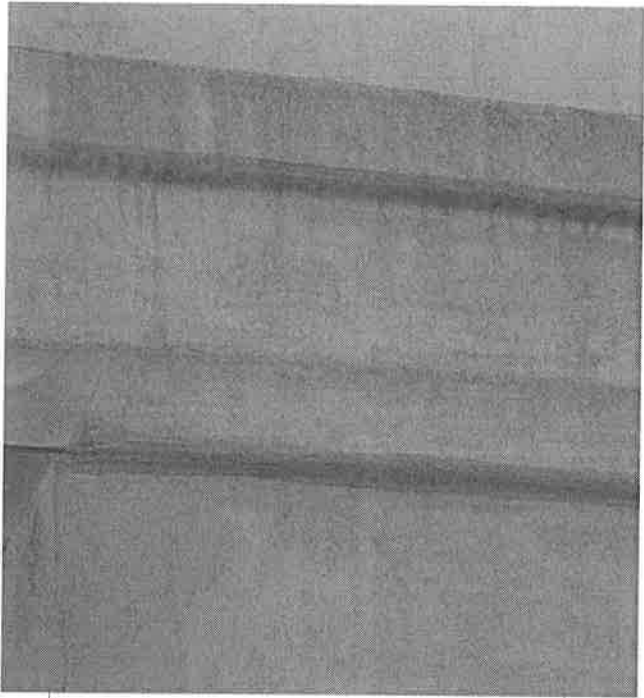
The next two pictures show the same area before and after Fog Coat application. This shows the good coverage of the etched area and the elimination of the problem. The Fog Coat has been applied to the two raised ridges and the area between the ridges but not to the wall below. The lighting is different in the two pictures accounting for the apparent color difference between the two pictures. In

**Before Fog Coat**

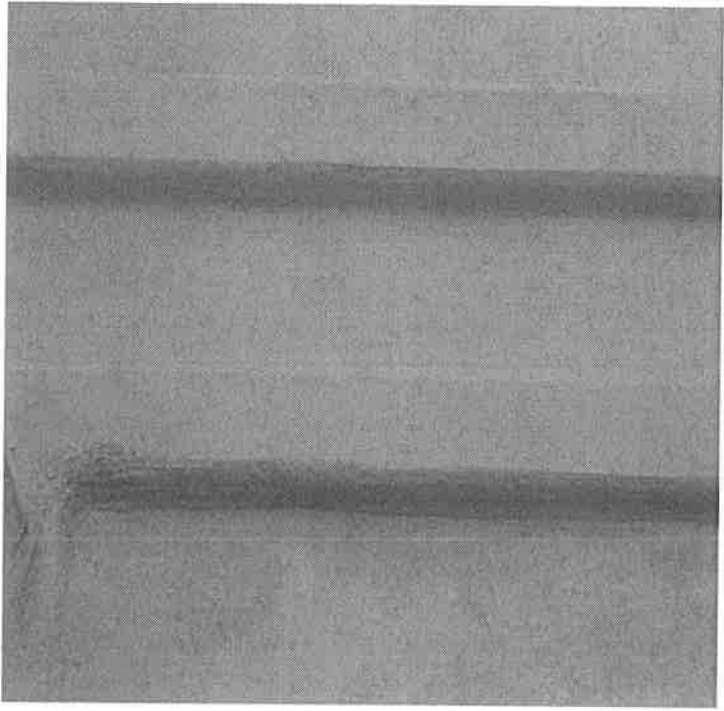
the bottom picture the fog coat has been applied to the two ridges and the area between but not below the bottom ridge.

**After Fog Coat**

This illustrates the close match in color between the coated and uncoated stucco.

I would recommend that this material be approved and offered as an option for units that have not been painted and whose appearance has been degraded by etching away of the surface layer of stucco as described here. I have done the work myself but painters can surely be found to do this. The material is easily prepared and applied. It is much more watery than paint requiring a little different technique, but I have done it and if I can do it, any good painter can do as well or better. I bought the fog coat from Cal Ply in San Jose. A 75 pound bag costs \$18 and I estimate that most units can be restored with one or at most two bags. It appears to me that restoring the etched areas does not require coverage of the entire unit.
